**Flood Control Project Maintenance
Levee Inspections**
LMA District Cover Sheet
Spring 2010 Levee Inspection Results

American River Flood Control District

Spring 2010 Levee Inspection Results

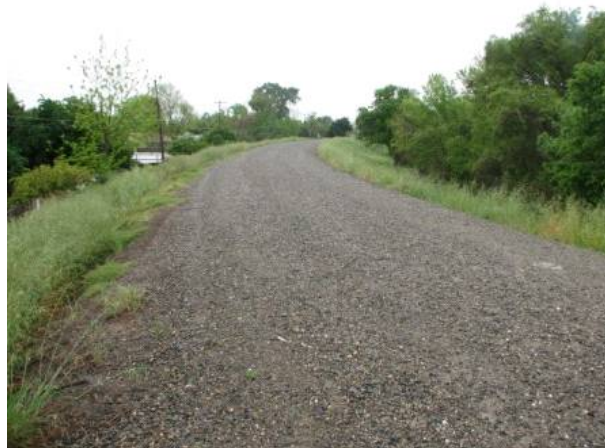
jpaasch_s_20100426_329.jpg

Annual grasses on levee slope.

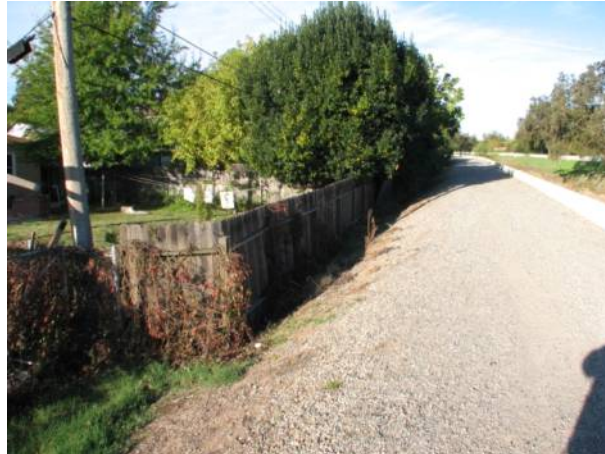
jpaasch_s_20100330_216.jpg

Fall 2009 photo: Wooden fence built on levee slope.

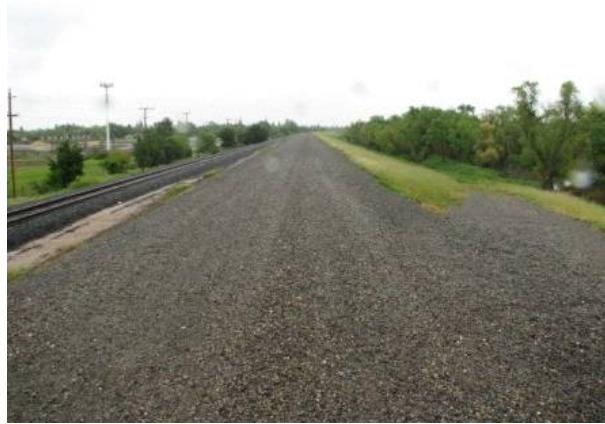
jpaasch_s_20100426_315.jpg

Annual grass on levee slope.

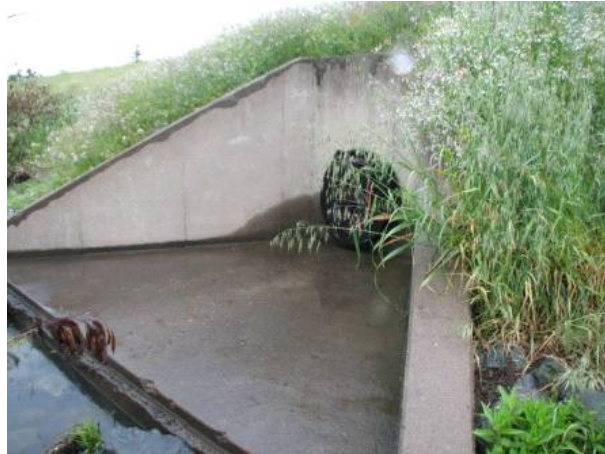
jpaasch_s_20100426_316.jpg

36" drainage outlet with functional flap gate.

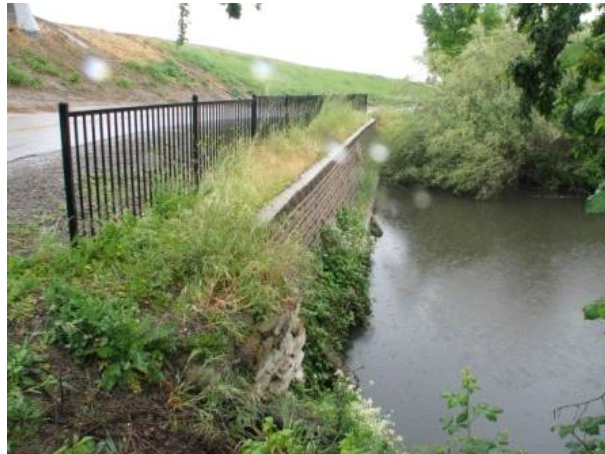
| jpaasch_s_20100426_332.jpg | |

| Drainage outfall to American River. | |

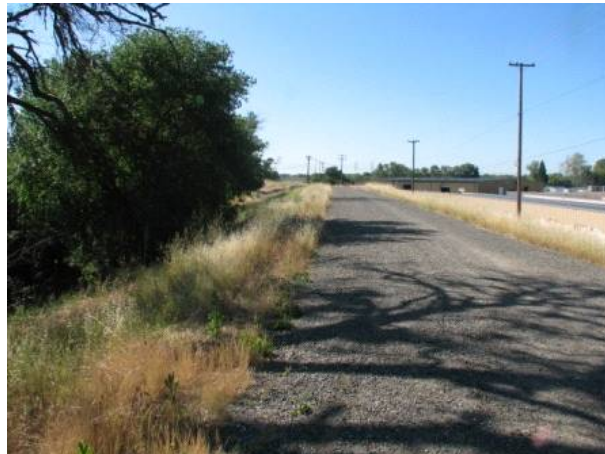
| jpaasch_s_20100514_401.jpg | |

| Annual grasses on levee slopes. | |

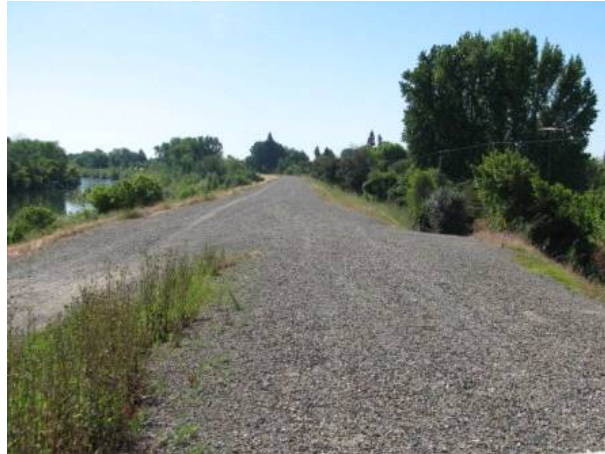
jpaasch_s_20100520_436.jpg

Annual grass on levee slope.

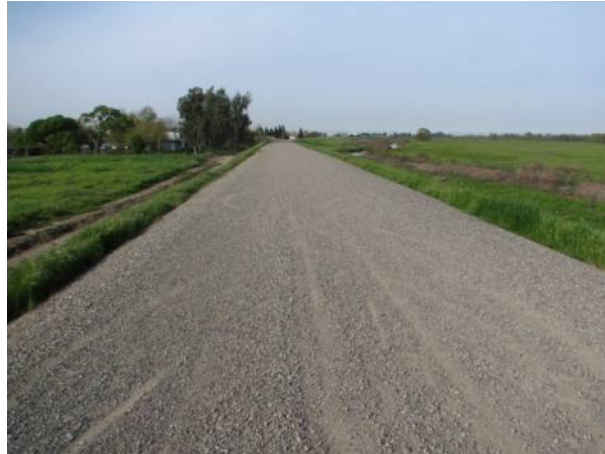
jpaasch_s_20100324_083.jpg

Annual grass on levee slopes. Photo looking downstream near LM 0.84.

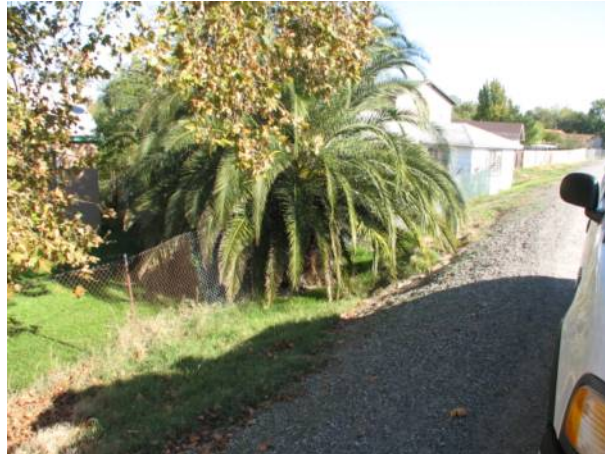
jpaasch_s_20100324_038.jpg

Fall 2009 photo of palm tree within 10-ft of the levee toe obstructs visibility and access.

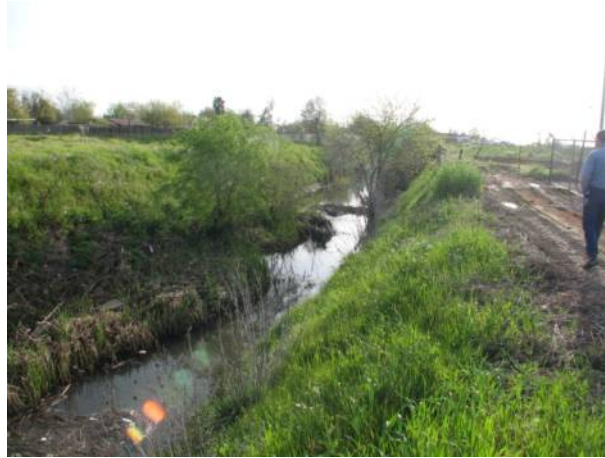
jpaasch_s_20100324_081.jpg

Incized channel at LM 0.48 upstream of Dry Creek Rd.

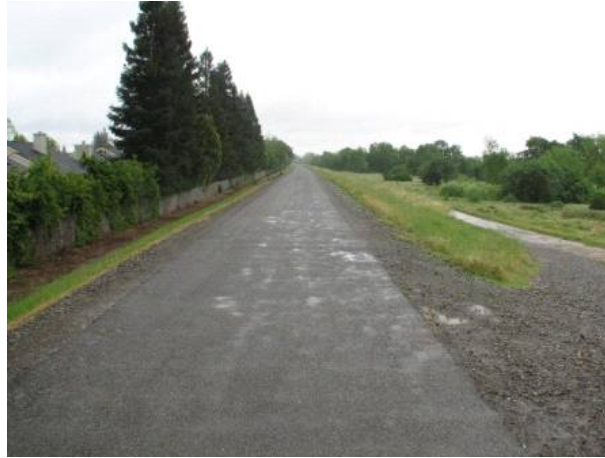
jpaasch_s_20100426_337.jpg

Annual grasses on levee slope.

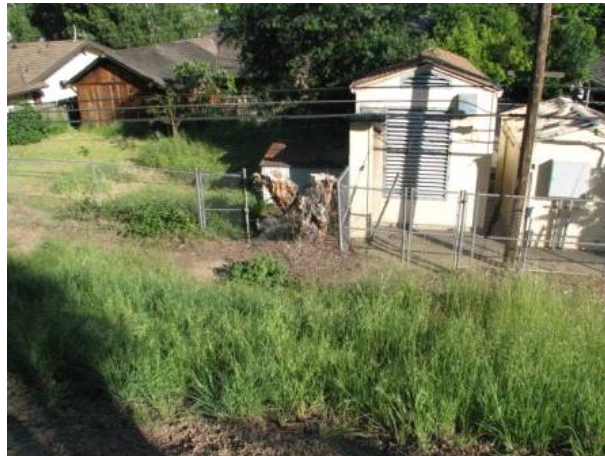
jpaasch_s_20100505_353.jpg

Tree trunk at fence line.

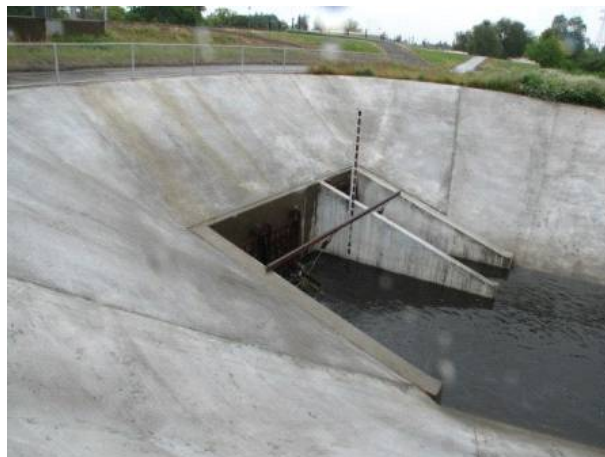
jpaasch_s_20100426_336.jpg

Gravity drainage to American River upstream of pumping plant.

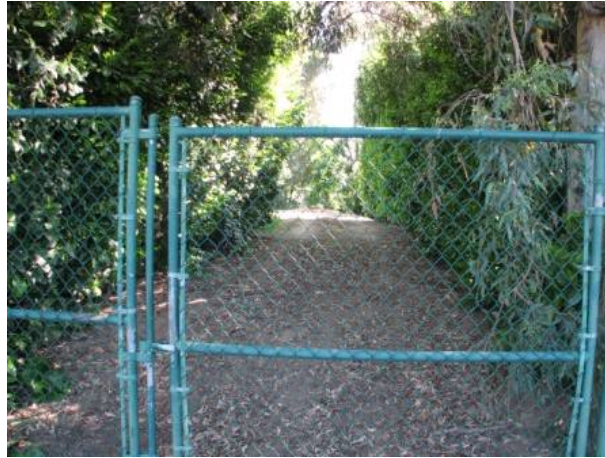
jpaasch_s_20100505_354.jpg

Levee encroached on by property owners north of Arden.

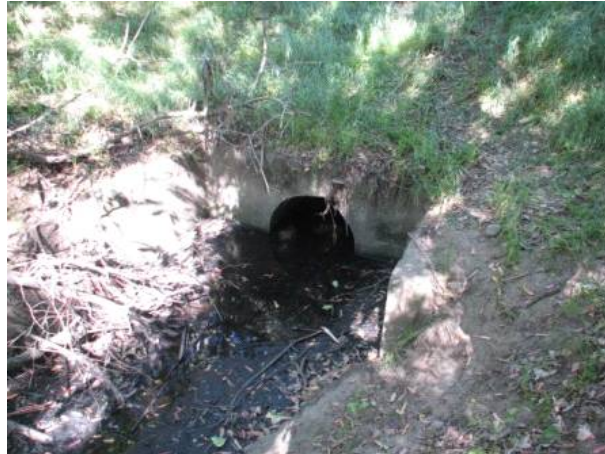
jpaasch_s_20100505_355.jpg

Drainage outfall in floodplain. Flap and slide gate in concrete box on waterside shoulder.

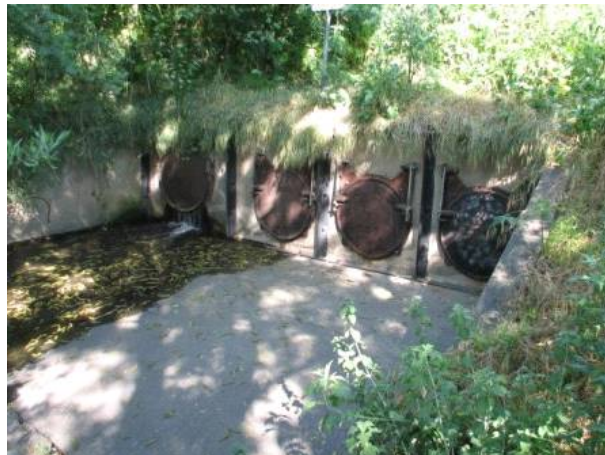
jpaasch_s_20100505_356.jpg

Flap gates at outfall in floodway.

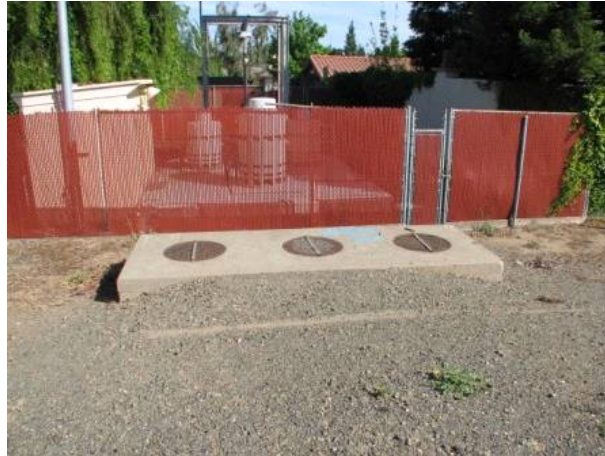
jpaasch_s_20100505_357.jpg

Pump plant at outfall.

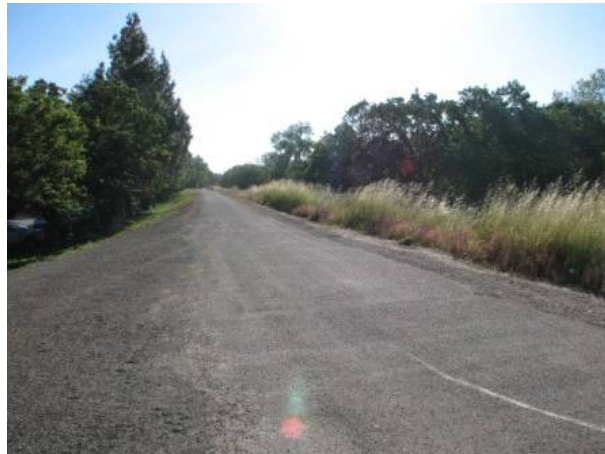
jpaasch_s_20100505_360.jpg

Annual grasses on waterside slope.

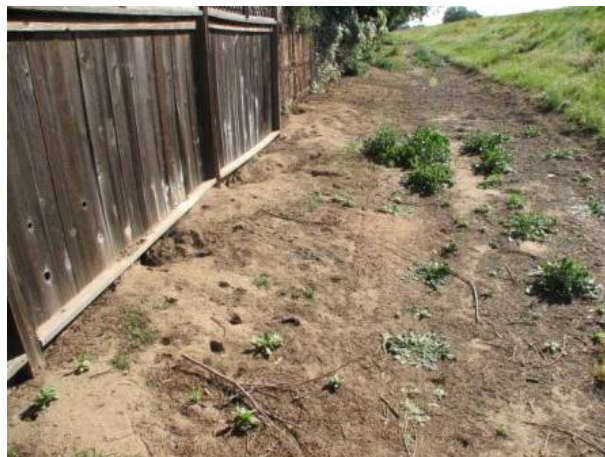
jpaasch_s_20100505_358.jpg

Active rodents persist along fence line.

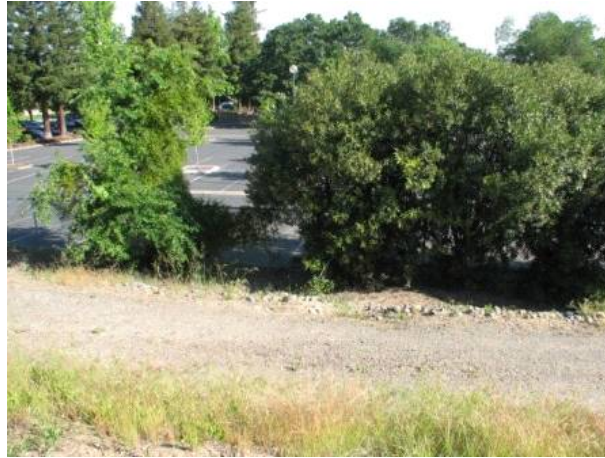
jpaasch_s_20100505_359.jpg

Trees at fence line obstruct access and visibility.

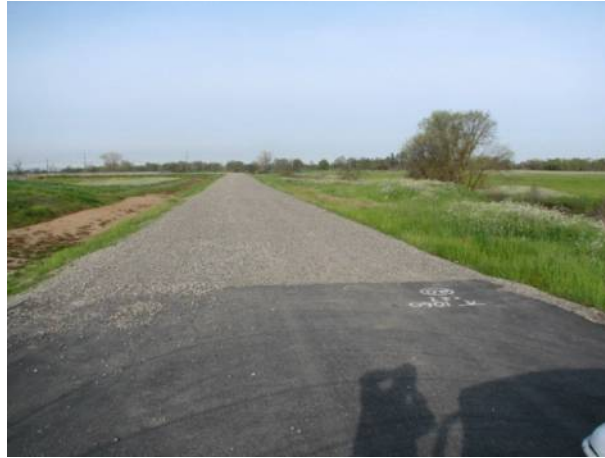
| jpaasch_s_20100324_082.jpg | |

| Annual grasses on levee slopes at upstream end of unit 11 at LM 0.70. | |
